Appendix 7

APPENDIX 7B. Worksites in Focus

Adams County Miltenerberger Road

Westmoreland County Powdermill Nature Reserve

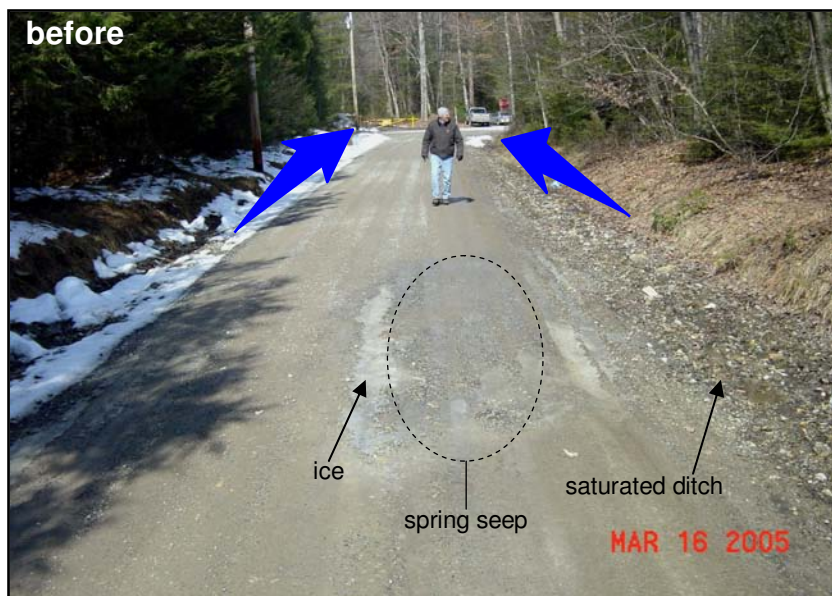
Photo 1. Notice the ice in the middle of the road from a spring seep. The entrenched road profile made it impossible to get water or snow off of the road.

Miltenerberger Road was an entrenched road with few outlets for drainage and spring flow to leave the road area. Water was concentrated in parallel ditches and directed 1,200' downhill and under State Route 233 into Conococheague Creek. Water entering the road area had nowhere to go but down the ditches, gaining velocity and erosive force. Adding additional drainage outlets was impossible with the road at an elevation much lower than that of the surrounding landscape. The entrenched road profile also left little room to plow snow (*Photo 1*).

Although over 3,000 feet of Miltenerberger Road was entrenched, cost limitations only allowed for enough shale to raise about 800 feet of the roadbed. Spring water entered the road profile as subsurface flow. This excess water saturated the road and ditches, softening the road base (*Photo 1*). The land surrounding the road is owned by the Bureau of Forestry.

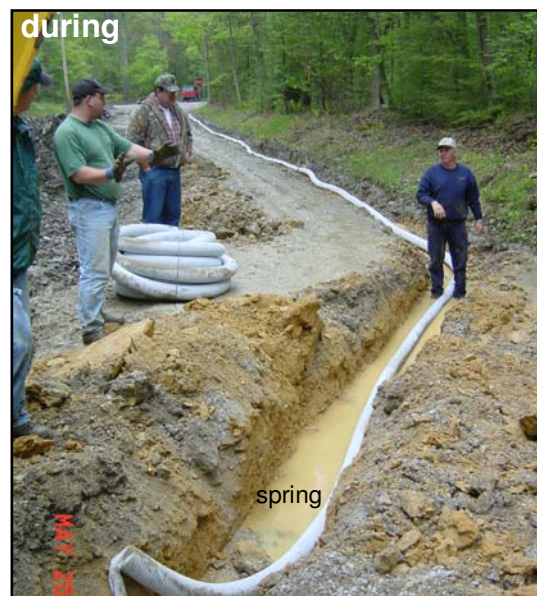
Photo 2. Pre-fabricated underdrain was used to collect subsurface water from under the road and both ditches.

Install underdrain: Pre-fabricated underdrain (4" perforate pipe wrapped in geotextile fabric) was placed under the road and ditches to collect subsurface water (*Photo 2*). The underdrain will keep clean subsurface water from mixing with road drainage. It will also reduce maintenance by allowing the road and ditches to dry.

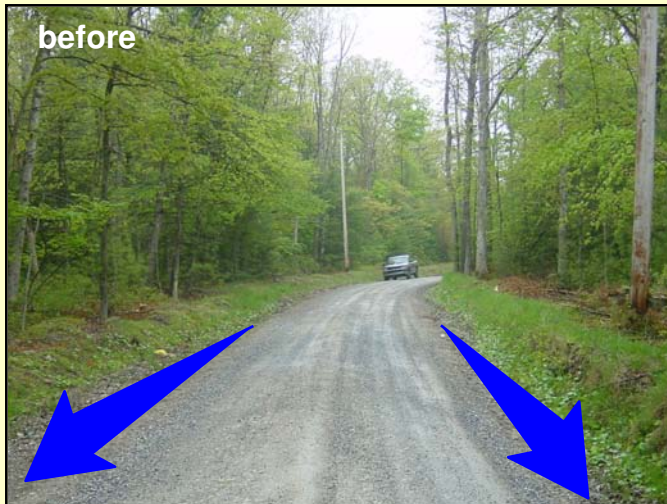
Photo 3. The entrenched road traps water in the road area and conveys it down to the stream. Note the elevation of the road relative to the utility pole on the right compared to *Photo 4*.

Raise the road elevation: Shale was purchased for use as road fill (*Photos 3 & 4*). The shale was spread with a bulldozer and compacted using a vibratory roller in approximately 8" lifts. The road was filled an average of 3' over an 800' length and tapered into the existing road grade on both ends. Filling the road completely eliminates one ditch, and provides the cover necessary to install crosspipes to outlet water from the remaining ditch (*Photo 5*).

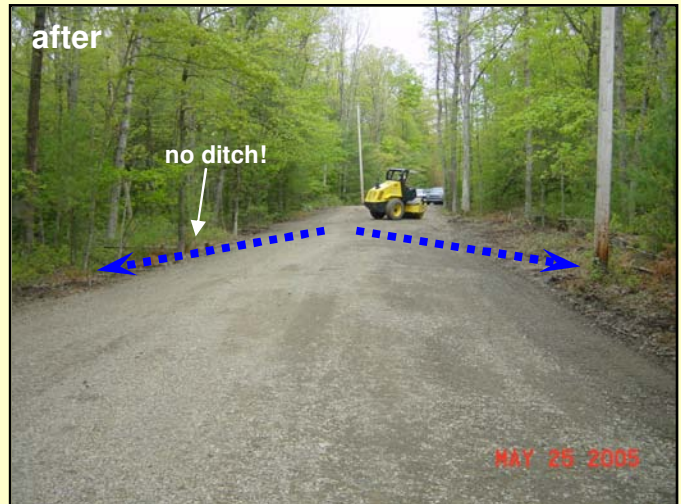
Photo 4. The road was elevated to eliminate the ditch on the left and achieve sheet flow. The added material also provided the necessary cover to install new crosspipes.

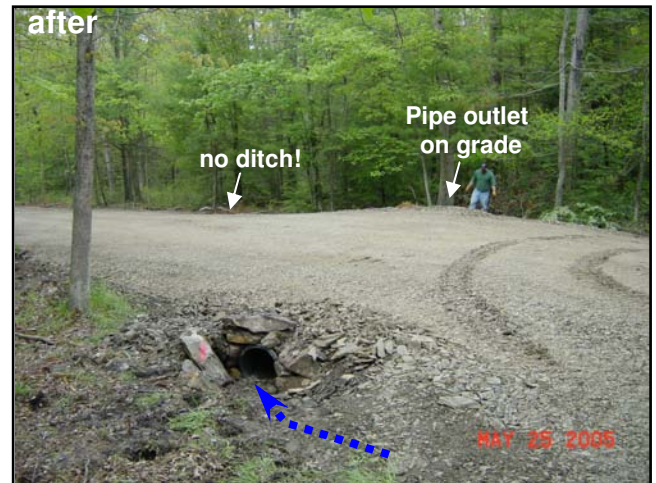
Photo 5. One of two new crosspipes installed. Notice the grade-break in the road over the pipe to get water off the road.

Install crosspipes: Because Miltenberger road was so severely entrenched, no crosspipes existed on the road before this project. Crosspipes were needed to divert drainage into vegetated areas and keep runoff from entering the stream. The new road elevation provided the extra cover needed for two shallow crosspipe installations. These crosspipes were outletted at the existing ground elevation to avoid creating an "outlet trench" into the woods. Gradebreaks were constructed over each crosspipe to obtain adequate pipe cover and divert water from running down the roadway (*photo 5*).

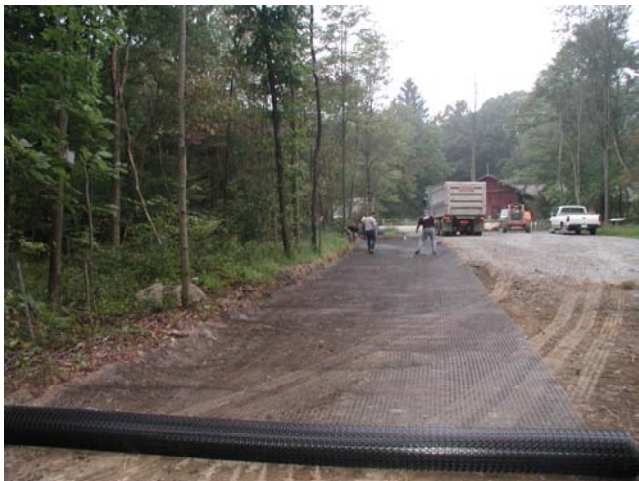
Above: Construction of the bus parking lane. Geogrid® was used to add support and tensile strength.

- A new driveway with Driving Surface Aggregate* (DSA-as modified) to improve circulation and provide second access to Rte. 381;
- 2 new parking areas: a bus parking lane underlain with Geogrid® (see photo below) and a pervious grassed automobile lot (60' x 100').

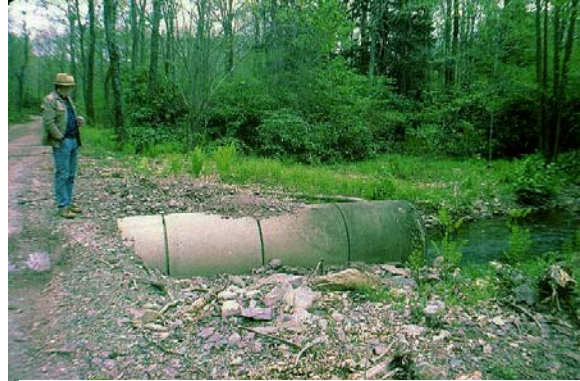
This site was a demonstration project for the Pennsylvania Dirt and Gravel Roads Program on which various practices were demonstrated. One of the sub-sites involved a 36"-diameter cement concrete pipe installed for a stream crossing Hell Hollow Road. Viewing the original site, one can see the voluminous [erosion](#) that had taken place, uncovering the outlet side of the pipe, which had actually lifted, causing water to run uphill through the

A7-01 Hell Hollow Road Demo Site: Existing site conditions prior to project.

pipe to the outlet side. The inlet side of the pipe was at an elevation that caused water to drop approximately 15" into the pipe entrance, which was causing changes in the stream's profile on the upstream side and thereby affecting the stream [ecology](#). The pipe was also out of alignment with the stream flow, causing tremendous [erosion](#) on the downstream bank, which was in direct line of the pipe outlet flow.

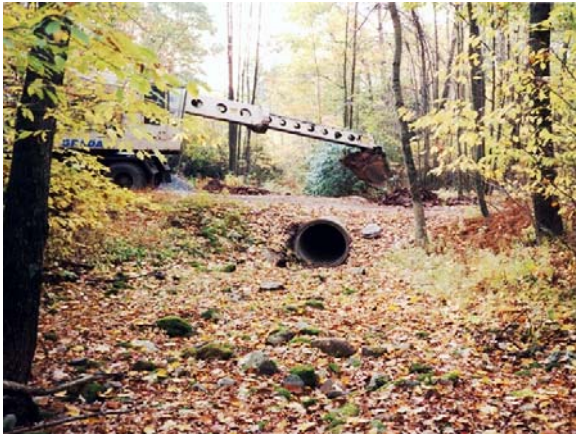
A7-02 Excavation of existing pipe during dry conditions.

The pipe was excavated and sections set aside. A new line and grade was established to better meet the stream flow conditions. Notice from the photos that all work was done during a dry period with no flow. The new pipe trench was prepared, and a [geotextile](#) separation fabric was then laid in the trench and extended both upstream and downstream. Bedding material was added, and the pipe sections were reset. Since the old pipe joints were not sealed and no sealing was available, the pipe was wrapped in a [geotextile](#) fabric to prevent losing fines through the joints with possible undermining of the material surrounding the pipe. Duct tape held the fabric in place for backfilling.

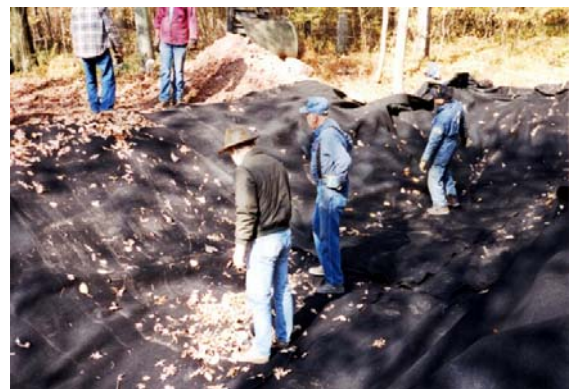
A7-03 Geotextile separation fabric laid in new trench.

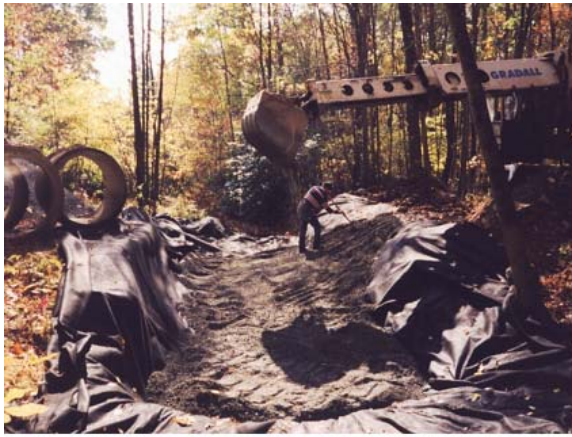
A7-04 Bedding material added

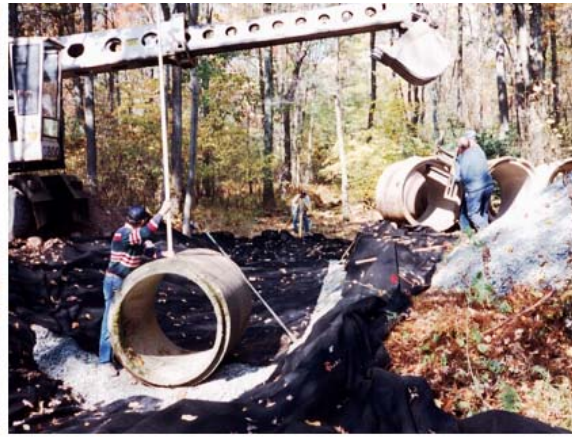
A7-05 New line and grade checked

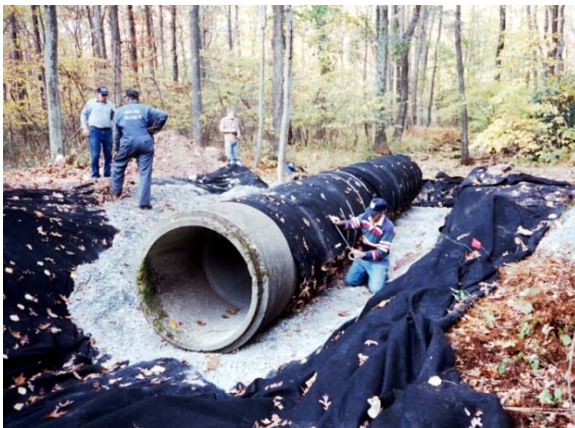
A7-06 Fabric wrap covers pipe joints, prevents fine material from entering.

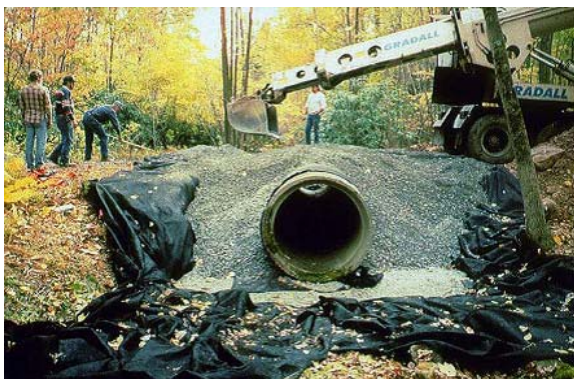
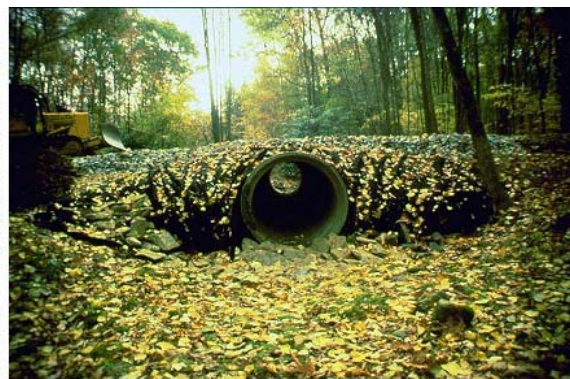
A7-07 After backfilling, fabric brought up and over pipe ends to encase entire installation.

After backfilling, the extended fabric was brought up and over the pipe ends, cutting out for the pipe inlet and outlet, and overlapped on top with a road separation fabric. Thus the whole pipe and backfill area was encased in fabric. Water could move through the pipe and through the

surrounding backfill, but the fabric prevented material removal, eliminating the [erosion](#) potential. The pipe end areas received large [riprap](#) to face off the embankment and further protect against [erosion](#).

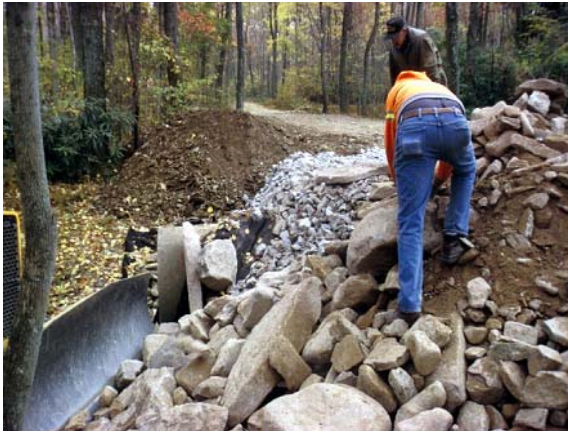
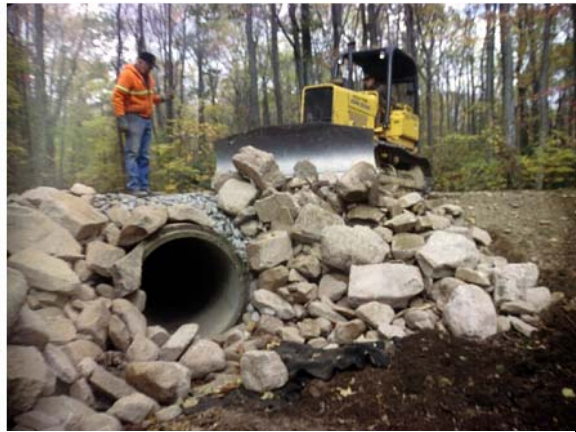
A7-08 Placing large size riprap at ends of pipe.

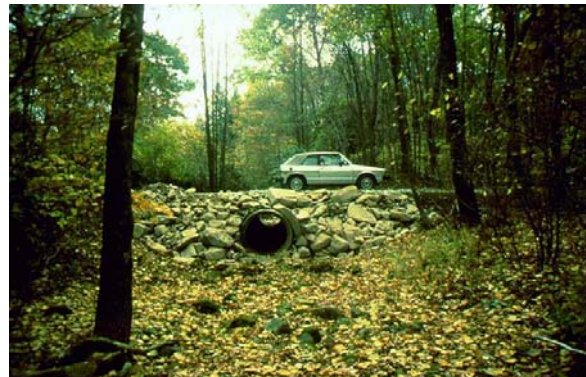
A7-09 Completed project with a leveled road stream saver system.

The road was leveled for a short distance on each side of the pipe crossing using the Stream Saver System discussed in Chapter 5, Section 5.3.6.1. The project was completed in the fall of the year.

The following spring brought the rains, which once more proved too much for the pipe to handle. The road has sustained overflows on several occasions each spring with minimal road damage. The site remains essentially [erosion](#) free. Road overflows are spread out over the

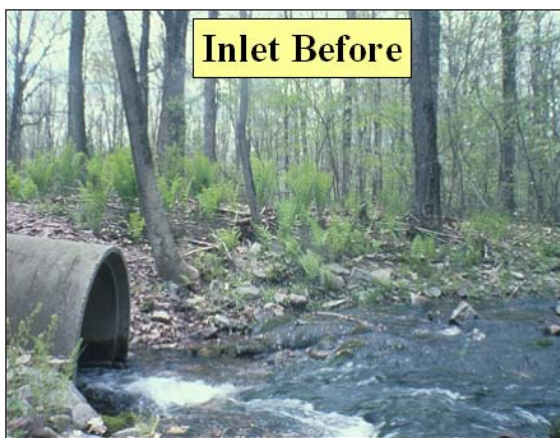
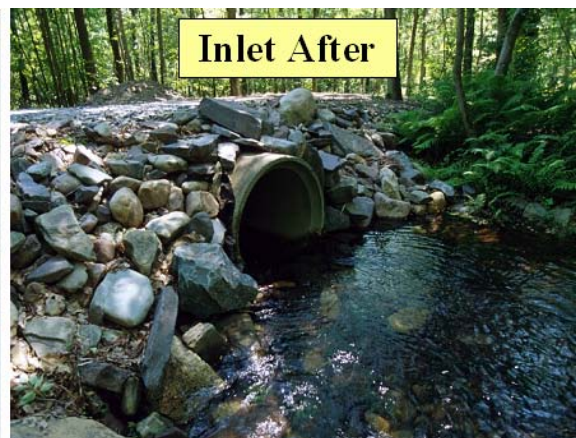
A7-10 Inlet conditions before and after project.

level road, reducing the velocity and energy of the water. The pipe is better aligned with the stream flow protecting the downstream banks against [erosion](#). The last photos, A7-10 and A7-11, show before and after conditions at each end of the pipe. The project demonstrates one innovative use of [geotextile](#) fabrics in solving the [erosion](#) and [sedimentation](#) pollution at this site.

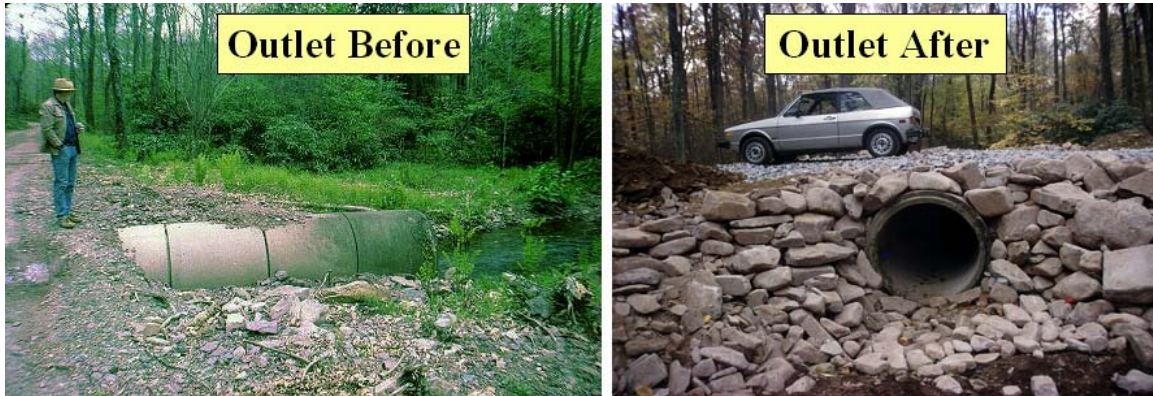
A7-11 Outlet conditions before and after the project.
